26th Street Wall Collapse

Baltimore City Department of Transportation

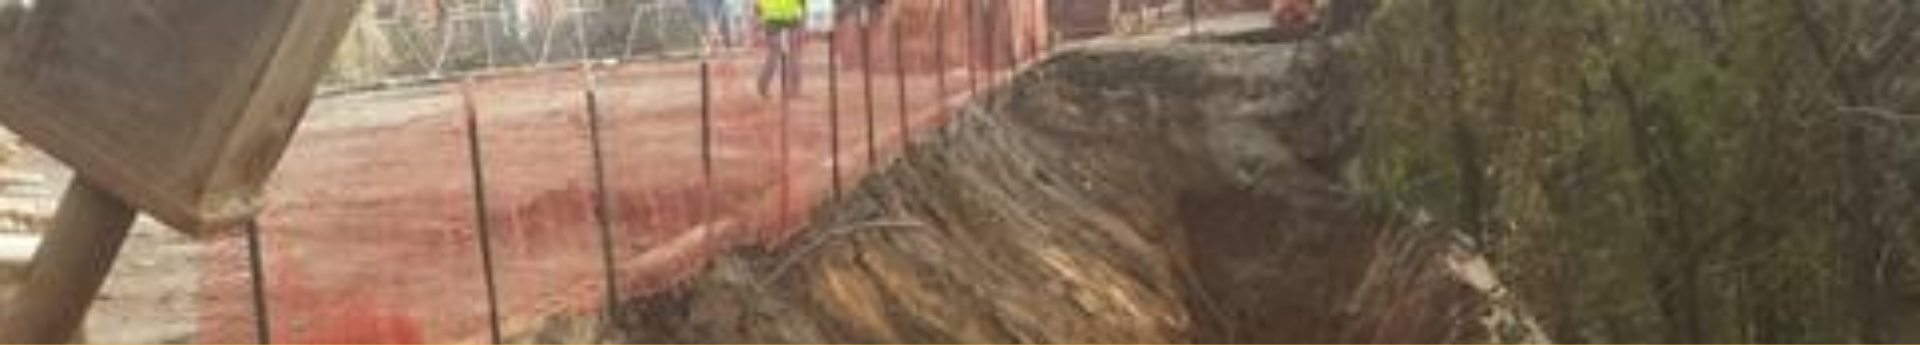
What Happened

- On Monday, November 26, 2018 a section of the retaining wall on East 26th Street above the CSX rail line through Charles Village partially buckled and began to fail.
- The potential failure of the retaining wall between North Calvert Street and Guilford Avenue caused DOT to close 26th Street. The wall failure also caused CSX Transportation to halt train operations for safety.
- DOT along with CSX and other city agencies assessed the situation.
- Contractor was mobilized and secured the compromised area.
- CSX resumed train operations at 2AM on November 27th.

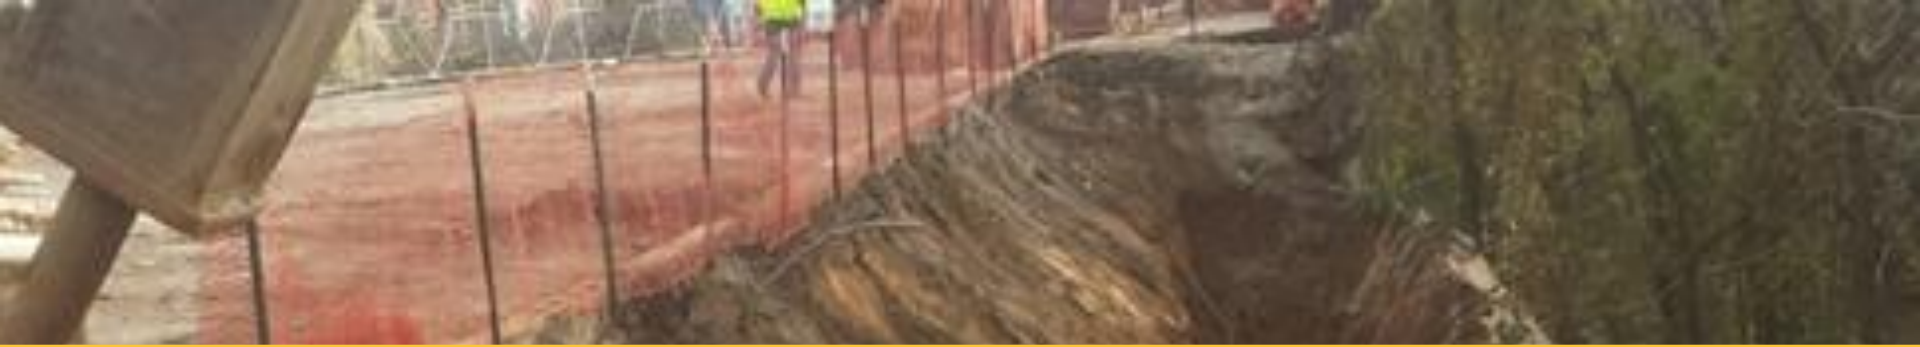
What Happened

- The original walls along the CSX tracks were built as far back as the early 1900s.
- Although there have been no definite conclusions established for the failures, contributing factors may include hydrostatic pressure caused by the record amount of rain, erosion of soil layer around the wall, etc.

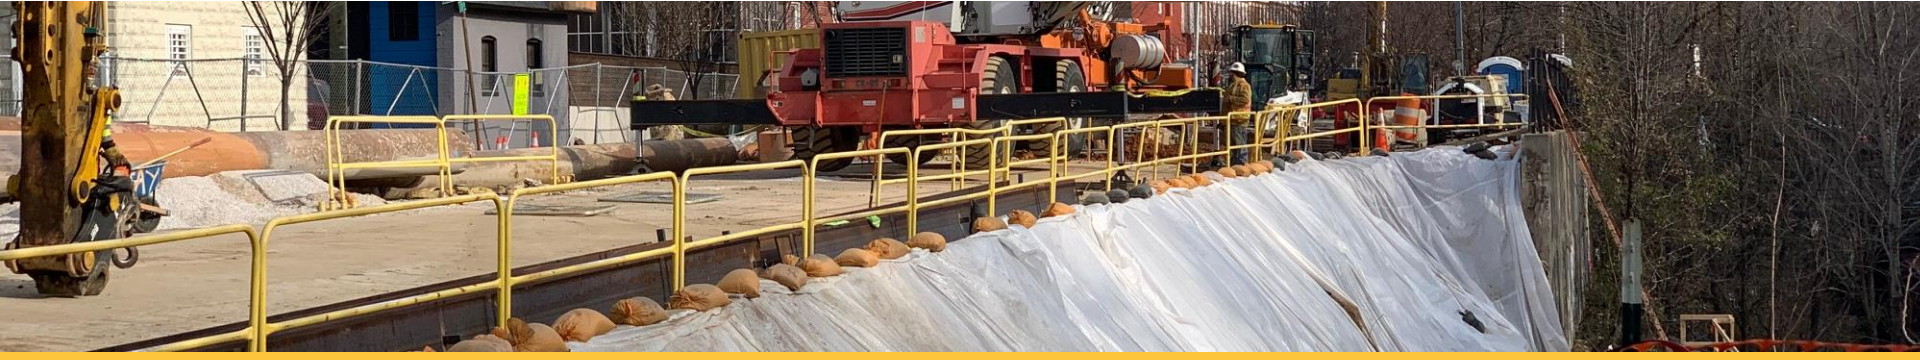
Current Progress

- The damaged upper wall has been removed.
- The slopes have been stabilized.
- Anti-erosion measures have been installed.
- The contractor is currently installing steel piles that will support access to the Lower Wall.
